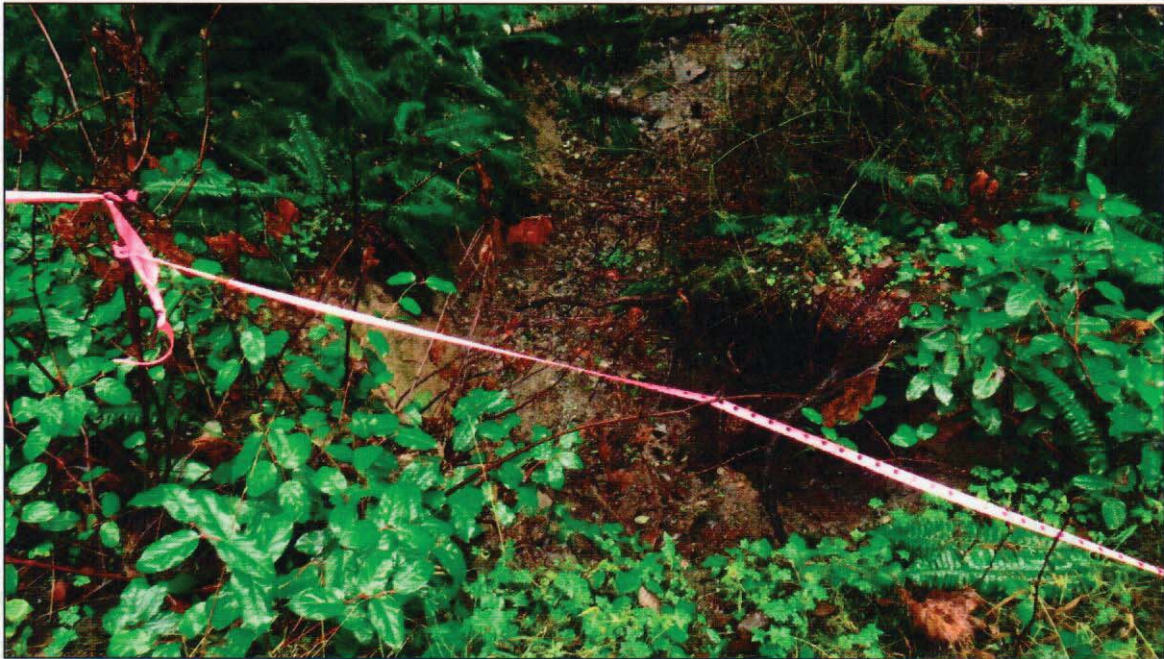
Figure 4: Thick, oversteepened road fill and slumping on Loveland Bay Road at stream crossing

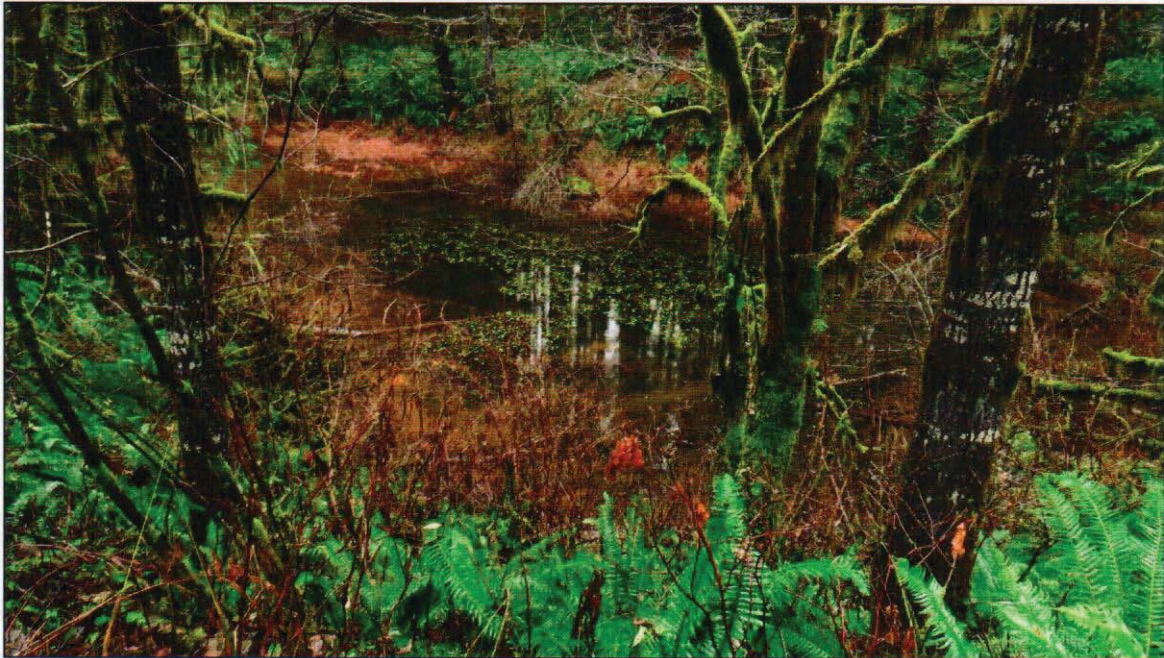
Figure 5: Stream flow impounded by undersized culvert, causing ponding, on Loveland Bay Road
