Myra Falls Mine Tailings Facility Field Review Report

Date of Field Review:	July 2019 (see below)	Date of Memo:	27 September 2019
File No.:	NX14001B1	Client:	Nyrstar Myra Falls Ltd.
Engineer:	Dan Hughes-Games, P.Eng.	To:	Keith Watson, P.Eng.
With:	n/a	Cc:	
Weather:	Sunny, seasonably warm, daytime highs in the upper 20s – all three dates in question.

Date of Field Review:	17 September 2019	Date of Memo:	27 September 2019
File No.:	NX14001B1	Client:	Nyrstar Myra Falls Ltd.
Engineer:	Dan Hughes-Games, P.Eng.	To:	Keith Watson, P.Eng.
With:	Dixie Ann Simon, P.Eng. Bryan Woods, P.Eng.	Cc:	
Weather:	Showers changing to rain, heavy at times. Temperatures between 10-20°

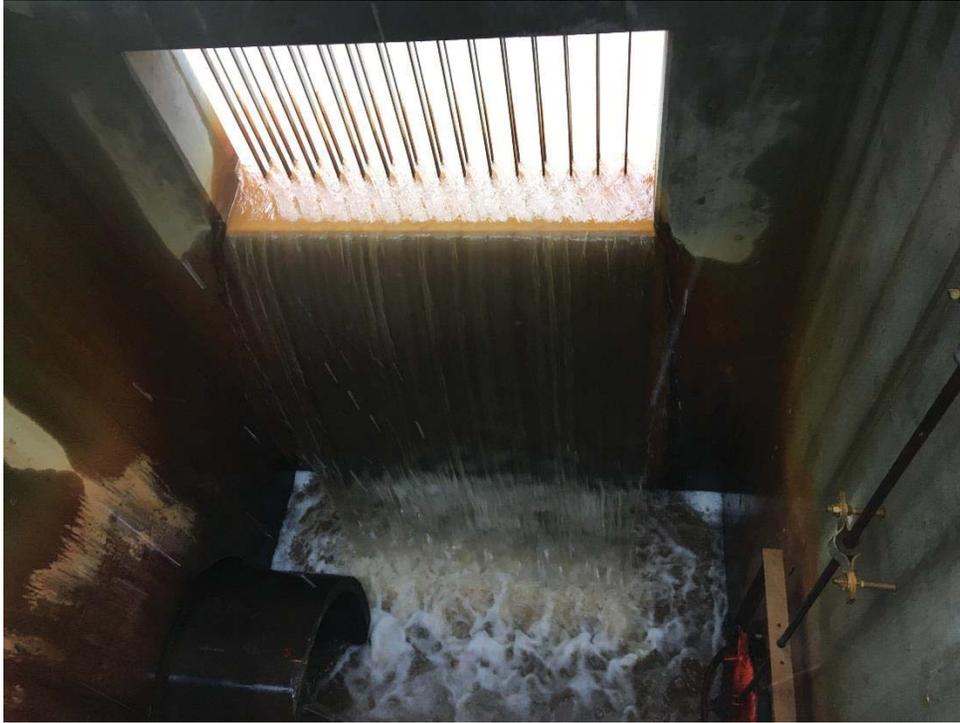
Photo 5: Flow through the Surge Pond decant inlet. Note the clarity of the water relative to Photo 3. The Surge Pond appears to be settling tailings solids as intended. The current level of sediment in the pond and the future need for dredging should be evaluated.

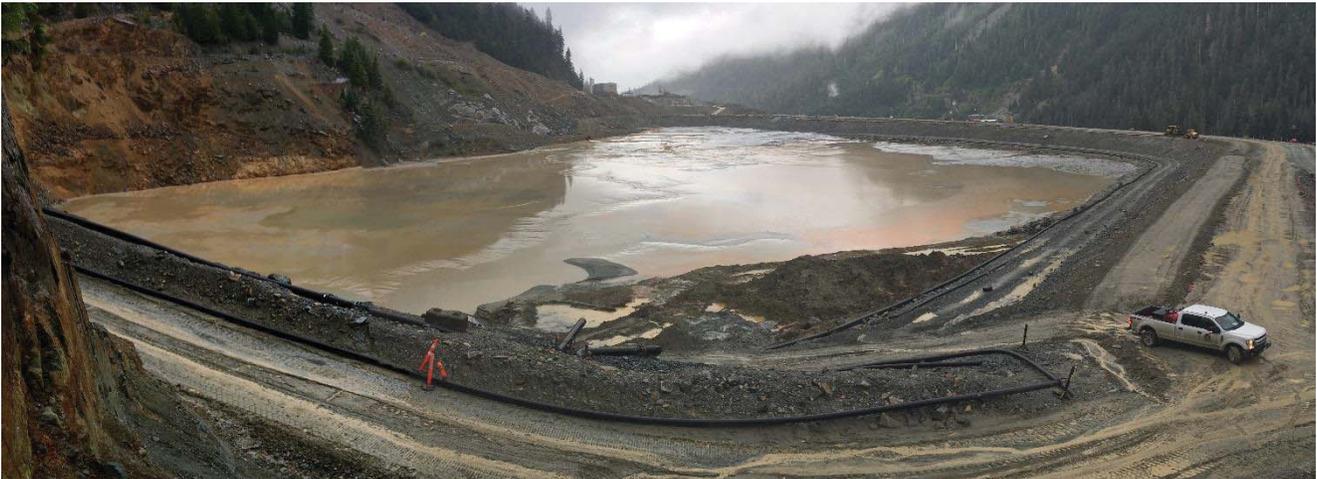
- Water level is as low as practically attainable, with dredgate slimes exposed across most of the impoundment surface.
- Sinkhole is visible. The location and size are consistent with prior observations since April 2019.
- Paste tailings deposition near the southeast corner continues. The tailings are displacing dredging slimes; however, there are islands and strips of dredgate trapped between deposition lobes.
- Cracking is present along the upstream crest, between about 2-3 m from the edge, primarily from Plane E to the east. The cracks were intermittent and open up to about 5 cm, with similar displacement across the. The cracks are thought to be likely due to consolidation settlement but should be monitored.
- Some ponding of water is present at the toe of the south arm in Panel 13 area. The area should be drained by pumping, as in past years.
-

Photo 6: Panorama of Lynx TDF from the 10L East portal. Water level is at the achievable minimum, with dredgate exposed across most of the surface. The sinkhole is visible with size and location consistent with prior observations.

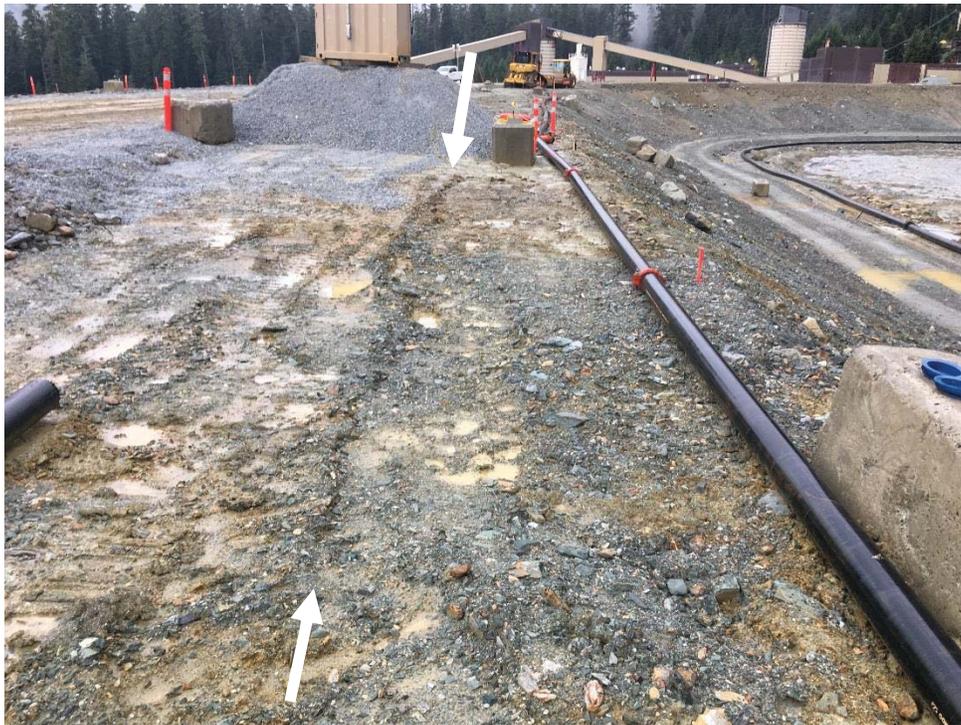
Photo 7: Crack on Lynx TDF Dam upstream crest near Plane E. The crack has apparent opening up to about 5 cm and has an apparent vertical offset of similar magnitude. This crack should be monitored for further development.

- The Old TDF and Lynx TDF facilities were reviewed by Wood.
- Action Items:
 1. Monitor cracking along the upstream slope of Lynx TDF.
 2. Inspect LLDD repairs during/after high flows.
 3. Spread the cake piles at the apex of the APA into the adjacent excavations if practical (if weather allows).

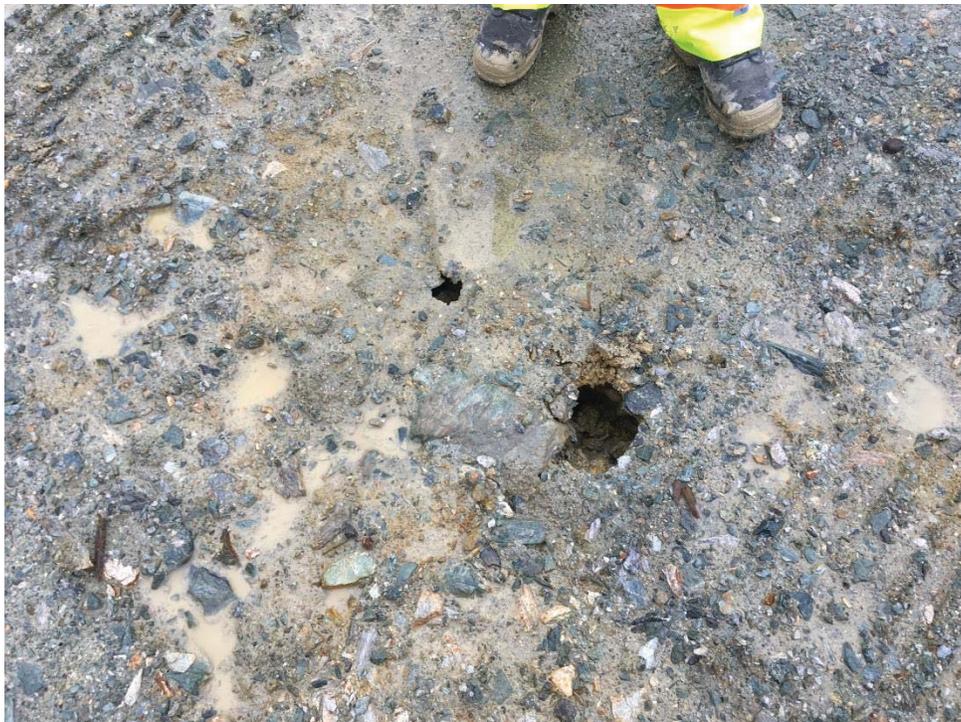
Photo 8: Voids found along the continuation of the alignment of the crack shown in Photo 7.
