PE:7008 QUARTER 4 REPORT

January through March 2021

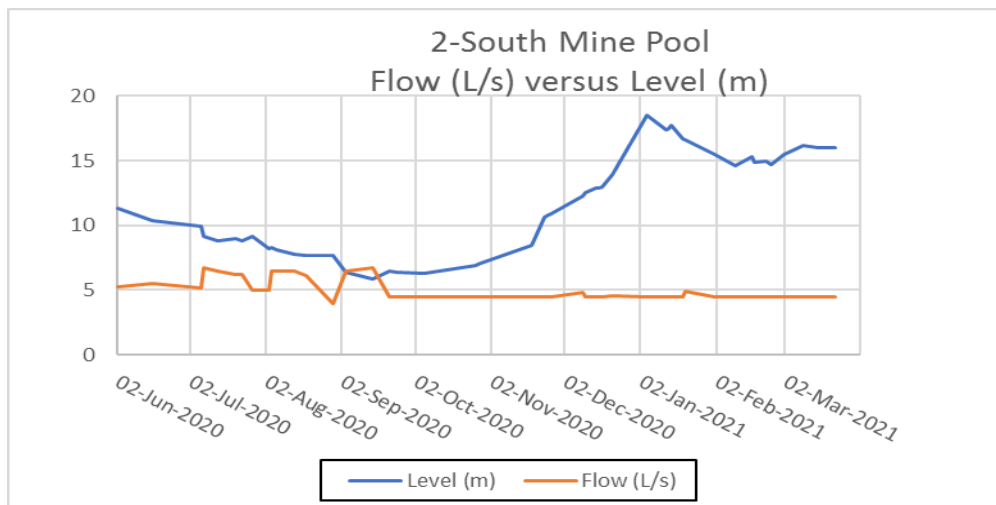
Figure 1: 2-South Mine Pool at INF Flow versus Level.

The PTS was operational from May 12th to present. The treatment system was operating at 4.5 L/s, Average amount of treated mine water pumped over the quarter (92 days) was approximately 46000 m³. The mine pool water level was measured at 6m above the pump on October 6 and increased to 18.5 m in early January with increased precipitation and declining to 16 m by the end of the March.

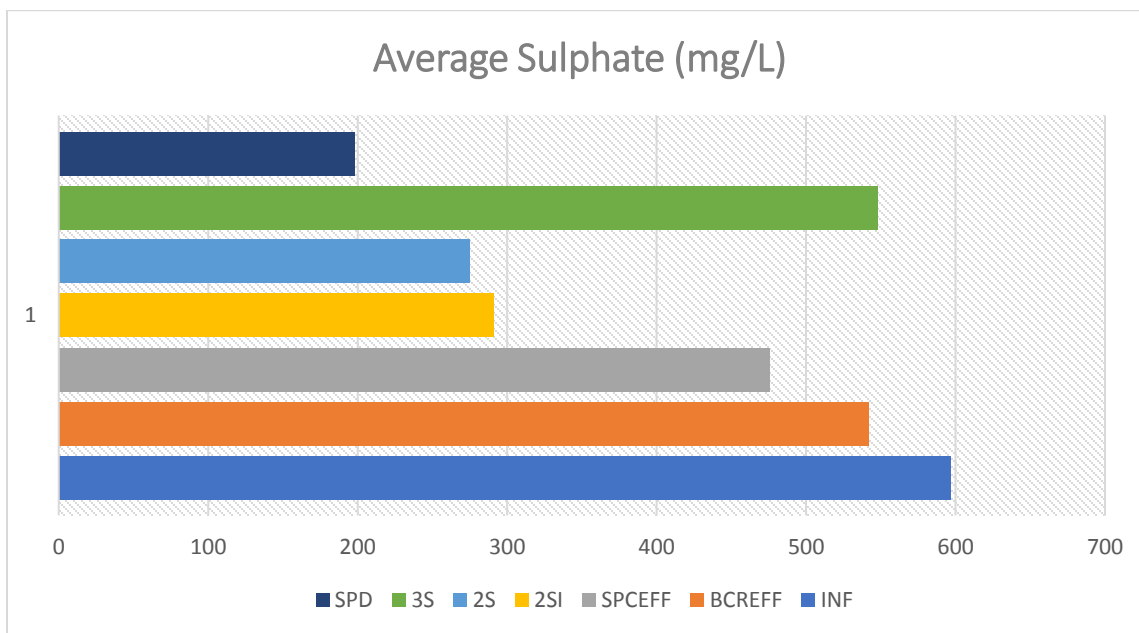
Figure 2: Average Sulphate Concentrations in 2-South Area

Average concentrations of dissolved sulphate have been entering the system from the 2-South mine pool measured at INF resulting in 597 mg/L and leaving the system at the Sulphide Polishing

Cell (SPCEFF) resulting in 476 mg/L. Refer to Table 5 and Figures 2 and 3 below. This has led to a reduction in average sulphate concentrations of 121 mg/L. Sulphate reduction between INF and Biochemical Reactor (BCR) averaged 66 mg/L. The station, 2-South Inflow (2SI), receives discharge from the PTS, had an average sulphate concentration of 291 mg/L and SPD averaged 198 mg/L for Q4.

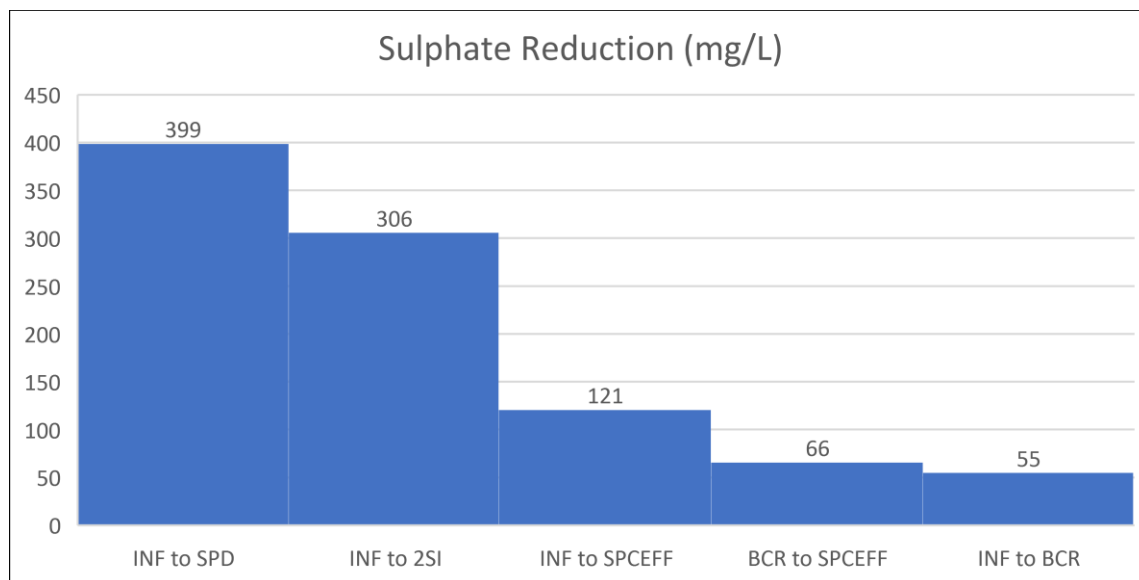
Figure 3: Sulphate Reduction through the Water Management System.

Overall, the greatest average sulphate reduction exists between INF to SPD resulting in 399 mg/L. Warmer ambient temperatures normally increase microbial metabolic activity within the BCR and SPC during summer and early fall. The low average reduction rate between INF and BCR could indicate that the substrate requires replacement in the BCR or the cooler ambient temperatures decreased microbial activities. Overall, a sulphate reduction of 399 mg/L was attained between INF and SPD. The original reduction goal has been achieved for the PTS, which was to reduce sulphate concentrations to 300 mg/L.
