Report Number: 067228

Re: Notice Letter, Permit 10807, Upland Excavating Ltd. - Campbell River, Refuse

Authorization: 10807	Upland Excavating Ltd.
NRIS IR #: 67228	September 11, 2017 Site Inspection Photos

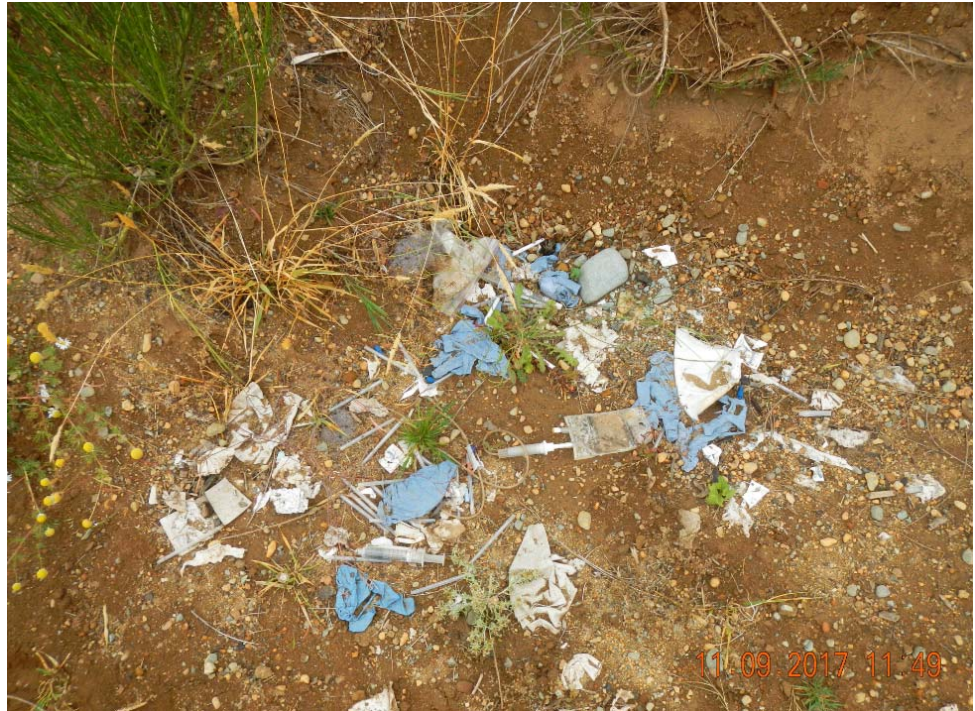
Photo 3

Details/Findings:	Refuse brought to the site is sorted prior to landfilling and inappropriate items removed and disposed of in an authorized manner or recycled. A very small amount of possible medical waste was noted on review of pictures from the inspection, though the source is unclear and disposal method appears inconsistent with standard site practice. The officer discussed the finding with Fagan and he notes screening of inbound material and staff education will be increased and site accessibility looked at. Materials consistent with demolition debris were noted at the site (Photos 2 and 3).
Compliance:	Not Determined
Actions to be taken:	Increase screening of inbound material and staff education as discussed; explore site access restriction as necessary.
Requirement Description:	Authorized Discharges and Related Requirements: Refuse 1.1.4: The works authorized are a landfill operation as directed, located approximately as shown on the attached Appendix A-1.

Medical waste noted along interior ditching of landfill.

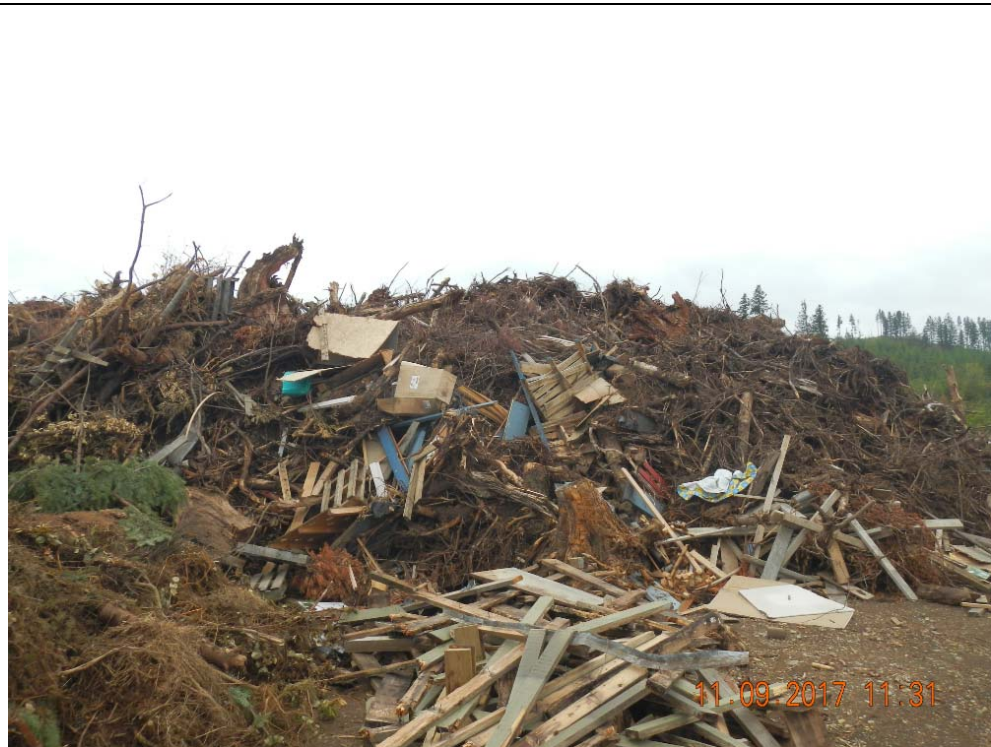
Photo 4

Burn stockpile. Non wood demo debris to be removed prior to burning.
